Sagadahoc County Courthouse Historic Brownstone Restoration

Project Summary

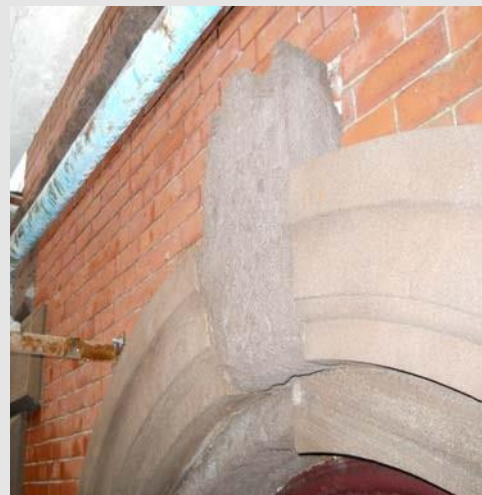
The restoration of the brownstone consisted of removing approximately 65% of the stone surface. The depths varied; however, one thing was consistent, the majority of the decorative portion was severely deteriorated. The stones were pneumatically treated until they were smooth and revealed a sound substrate with a ¼” profile. Patching was completed using Jahn M-70 repair mortar, sculpted to mimic the original gothic profiles using special templates designed by the Knowles’ team. Many of the stones required that we perform much of the work by hand using the templates to verify accuracy. Knowles workers were more like sculptors than masons. The temperatures experienced during the winter of 2011-2012 created difficult conditions for proper curing of the brownstone repair. A series of heaters, fans, and ventilation were designed to maintain the required curing temperature of 60°F to 70°F.

The flashing installation on the 1986 structure required the erection of shoring to stabilize the two stories of CMU above. At the mid-level of the first floor, there were three courses of CMU around 195 linear feet of the building that needed to be removed prior to installation of the new flashing. The flashing was fabricated off site and installed to allow for proper weeping of any moisture within the cavity. The CMU was then re-installed. Finally, two coats of Cathedral Stone Product MasonRE Stain were applied to the entire CMU structure to enhance the appearance and reduce water infiltration through the porous block.

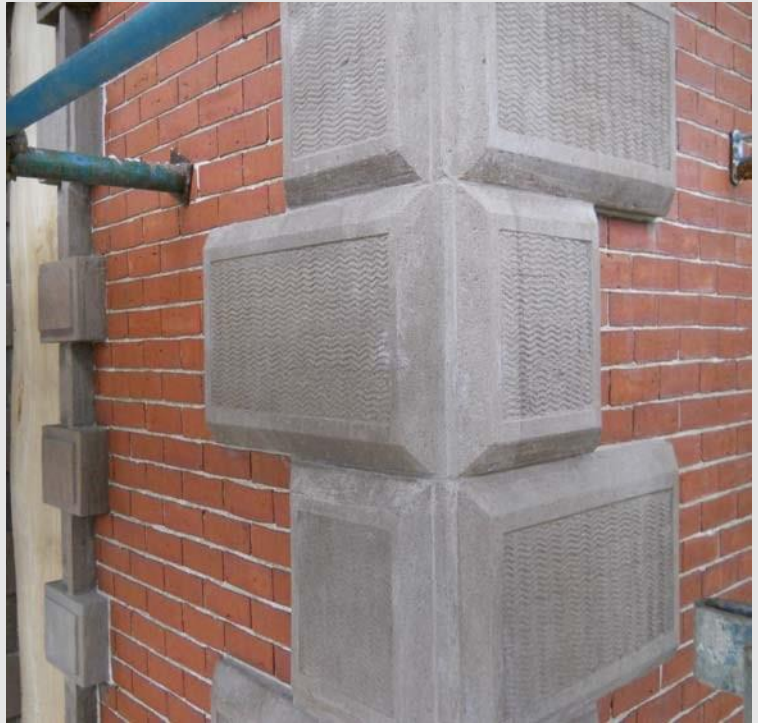
The process we used for the purpose of replicating the original architectural profiles proved to be difficult, but innovative. With only partial samples of the original intact stones, profiles were found using sections from many different areas of the building. Complete two dimensional template profiles were designed for all sections of the brownstone. They were first constructed on cardboard, validated, and then fabricated from 12 gauge steel. These templates essentially became our trowels for repairing and mimicking the original profiles. These templates worked well for the stone capitals, keystones, window surrounds, and band stones. The corner quoins, which equated to approximately 75% of the brownstone repair, did not have a consistent pattern that could be repaired using templates. These quoins were originally constructed with a special tooling technique. These stones were all carved by hand using specialized dental tools. To stay consistent with our repairs, only three masons were allowed to work on the quoins.

All the pneumatic work was completed on the façade prior to any application of material because the vibration could break the bond between the patch and the original stone. Once the patching began, the masons had to apply the material just past finish grade to allow for the material to be carved to match the original profiles. Once the material was installed, it had to set for 2 to 3 hours before it could be carved, depending on the depth of the patch. On average, each mason could complete 5 to 6 stones per day. Quality control was essential in batching and application. If there was any variance in the water quantity during mixing or application, the color of the repairs would become inconsistent.

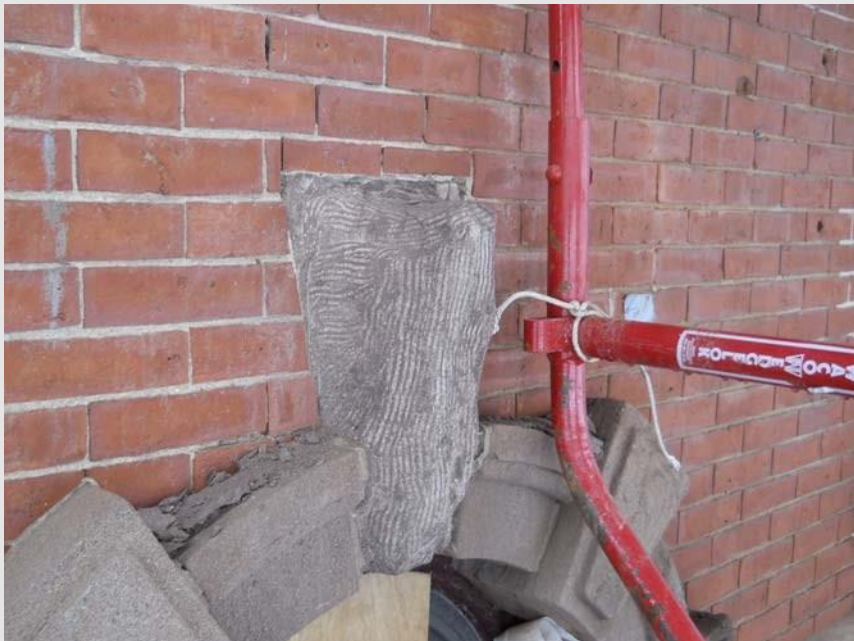
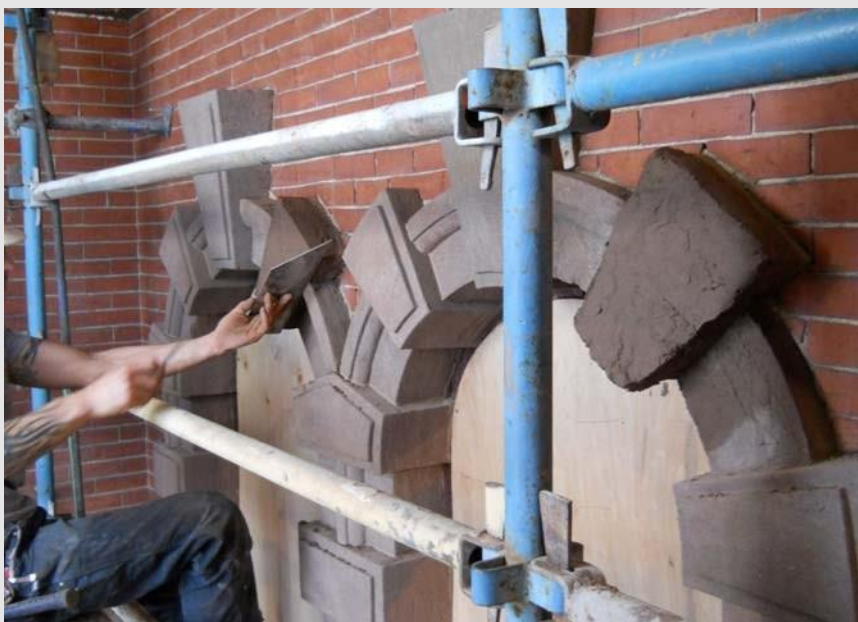
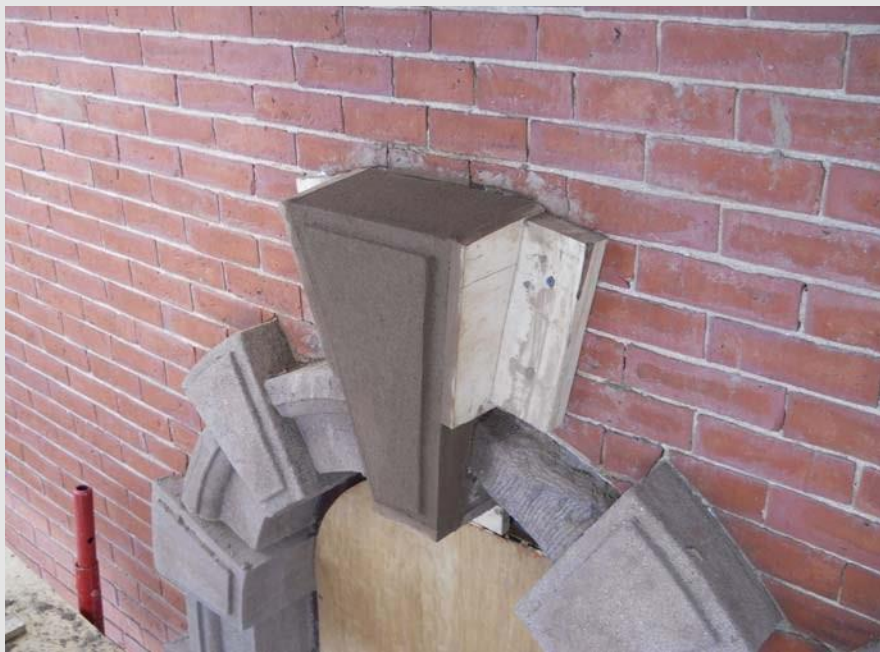
Additionally, the repaired stones and the few stones that did not need repair had different water absorption rates. Once wet, the color of the repaired stone appeared slightly darker than that of the existing. We applied a water base all natural sealer to maintain a similar appearance over the entire brownstone.

For the 1986 structure, the obvious omission during original construction was flashing installation and a weeper system. At the lower return where the CMU goes from a 12" wide block to an 8" wide block above, any infiltration from above would pool up and leak through the back-up system. This required the installation of new flashing. In order to allow for removal of the block at this level, shoring had to be erected to stabilize the two stories of CMU above. Once the flashing was properly installed, the new CMU was laid back with a proper weeper system. To help reduce the elevated levels of water infiltration through the CMU, a special coating was applied to the surface. The product used was MasonRE Mineral Coating. It is specially designed for porous masonry because it allows for water vapor to escape while stopping water infiltration.
